T.S.B. No.:
AC No 10 /08

PRODUCT:
Climate Control

MARQUE:
All Vehicles

SUBJECT:
A/C loop flush after
compressor failure

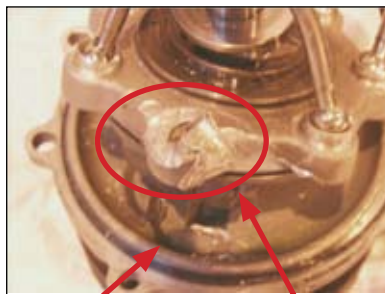
Damaged piston rings Damage to scroll plate

The A/C system must be thoroughly flushed in the event of a compressor failure to prevent particles remaining inside the A/C loop. Rapid catastrophic failure of the new compressor will occur if a flush of the system is not carried out. Removing and cleaning individual components from the system will not be sufficient. Only flushing the system using appropriate equipment (available as an option for Valeo ClimFill unit, P/N 699955) which has been connected into the A/C loop will sufficiently eradicate damaging particles. A clean A/C system is most important for the system to remain functioning perfectly and efficiently.

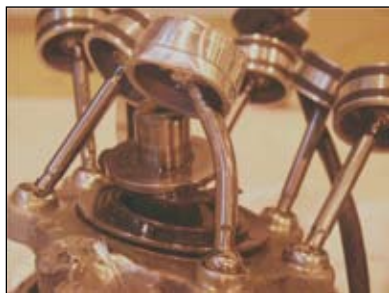
Additional piston damage

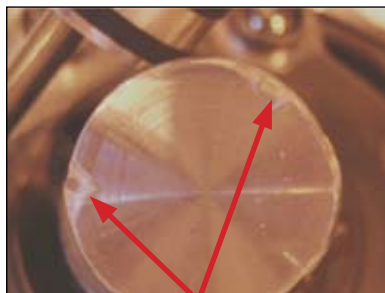
Damage to piston crown
